Technical Report

number 5

PERFORMANCE OF AESP TRANSMISSION/RECEPTION EQUIPMENT

SUMMER AND FALL, 1974

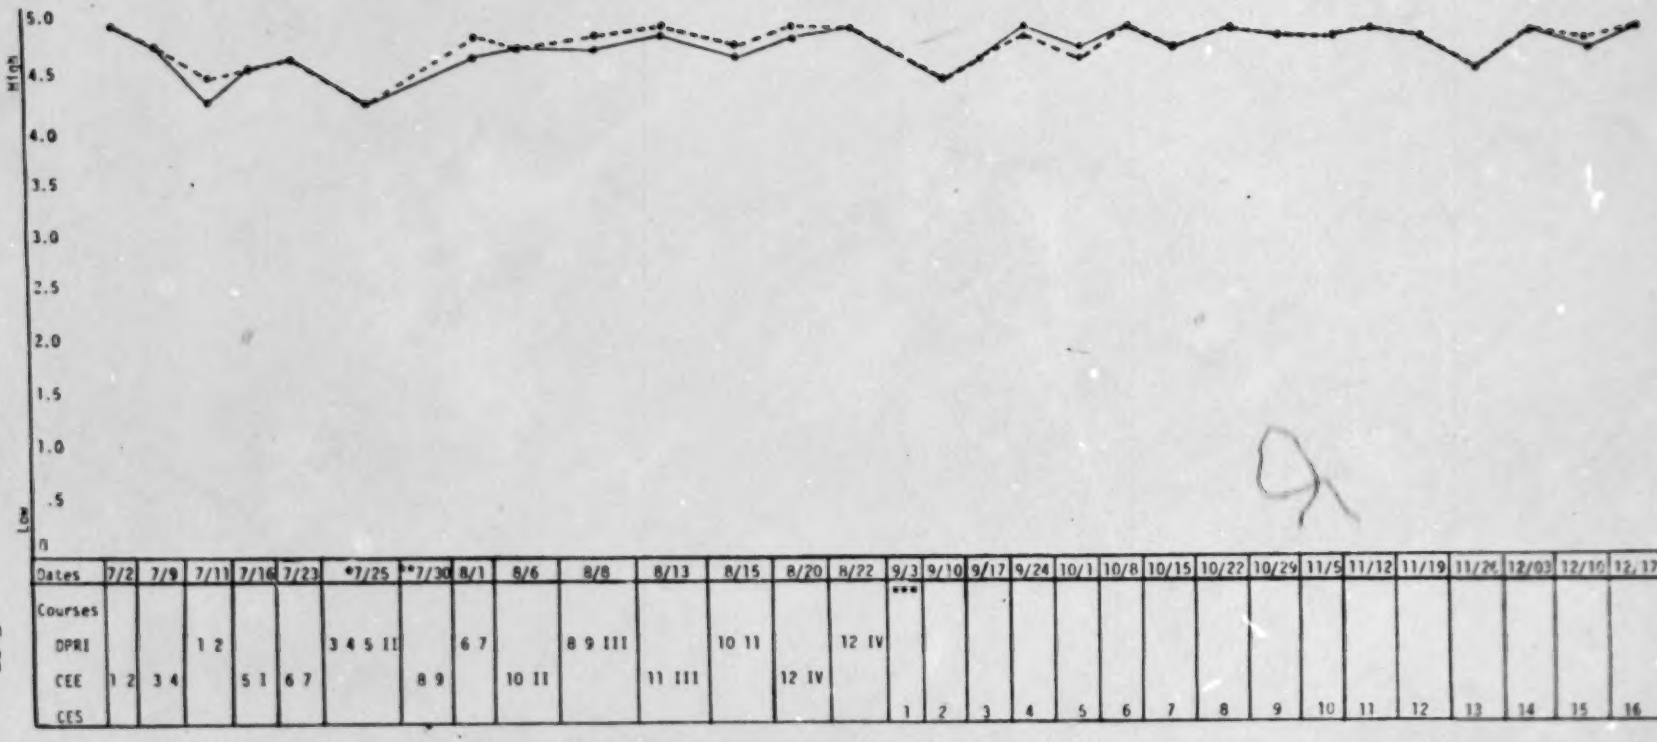
FIG. 5: QUALITY OF TELEVISION PICTURE RECEPTION IN AESP COURSES

* Programs 3 and 4 and Seminar I, originally scheduled for July 18, rescheduled or deleted due to failure at the uplink station.

*** Seminar I, scheduled for September 3, deleted due to systemwide delivery problems.

the television picture. The closer to 5 the rating, the less distortion was perceived. As shown by the broken line in Figure 5, what distortion there was was only slightly annoying. The closer to 5 the rating, the less objectionable the raters felt the distortion was. The fact that the broken line is usually higher rather than lower than the solid line indicates that site coordinators felt the distortion observed did not impair reception, since they tended to distinguish more distortion than they felt annoyance.

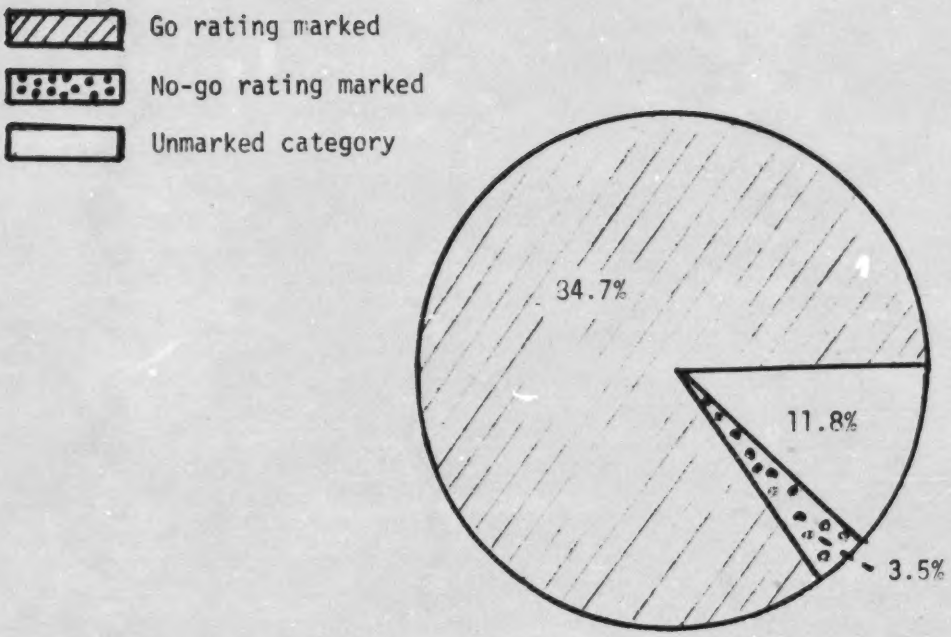
FIG. 7: PROPORTION OF SITES WITH ACCEPTABLE TELEVISION PICTURE

To be categorized as a go-situation, the televised picture had to be rated 3 or higher on the dimensions of perceptability of distortion and 4 or higher on annoyance attributed to the distortion; the television sound had to be rated 2 or higher on the dimensions of readability and signal strength. As shown in Figures 7 and 8, as many as

96.5% of the sites had an acceptable television picture for the 24 pretaped and 24 live televised programs broadcast in 1974, and as many as 95.3% had acceptable television sound.

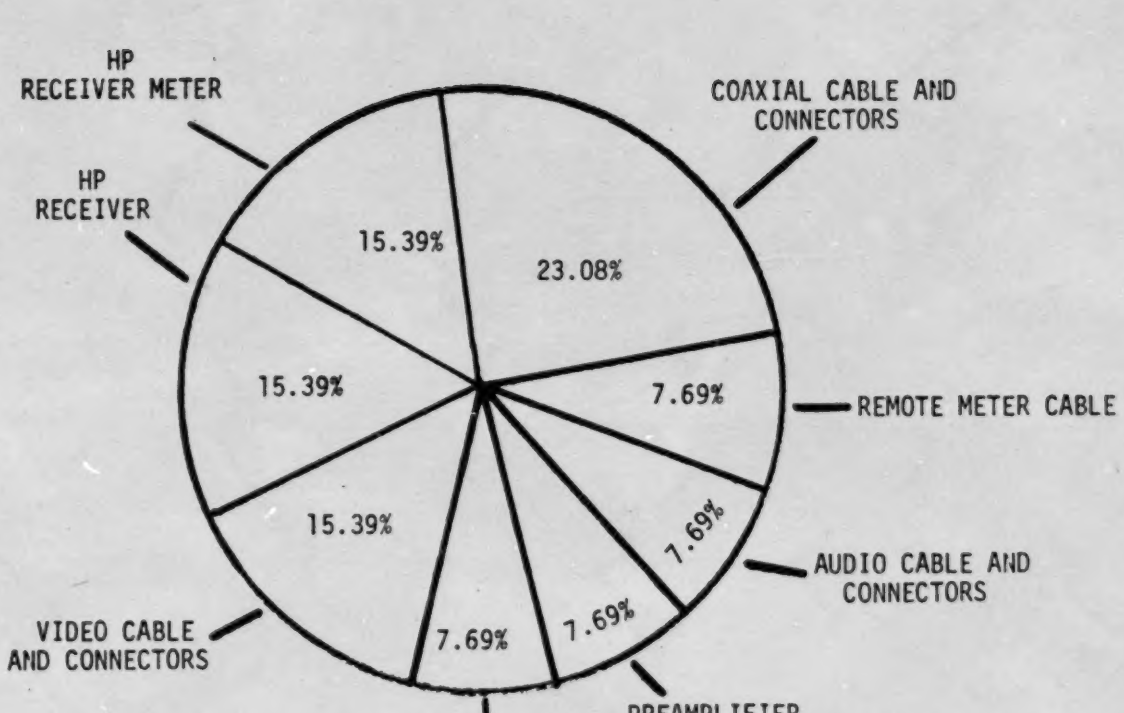
FIG. 9: PROPORTION OF MALFUNCTIONS IN TELEVISION RECEPTION SYSTEM BY EQUIPMENT

During the first six-month period when a total of 34 hours of televised programs was scheduled for transmission over ATS-6, 13 malfunctions in site television reception equipment were reported to AESP Engineering. Table 3 lists the cause and date of each malfunction at each site; the total number of times, across all sites, each type of malfunction occurred; and the television programs missed due to the malfunction. Sometimes a malfunction occurred and no television programs were missed, either because the malfunction did not make reception impossible or because repairs were made before the program began. Out of 720 program transmissions (48 programs times 15 sites), 18 programs (2.5%) were not received because site equipment malfunctioned.

attributable to specific pieces of equipment in the system. This proportion is found by dividing the breakdown frequency of each piece of equipment in the system by the total number of malfunctions in the system. As indicated in Figure 9, the cables and connectors caused over half the problems. It should be pointed out that the H.P. receiver was not inoperative when the monitoring device on the receiver for measuring signal strength malfunctioned and that most H.P. receiver malfunctions simply involved blown fuses. Therefore, the weakest link in the system appears to be the cables and connectors that tended to break if repeatedly moved.

1) Mount the receiver directly on the receiving antenna so that the coaxial cable, responsible for the most malfunctions, could be replaced with a less expensive, less complicated, and lighter video cable that would place less strain on the connector.

2) Install the equipment permanently in one place to reduce the number of breaks in the connections due to movement of the equipment.

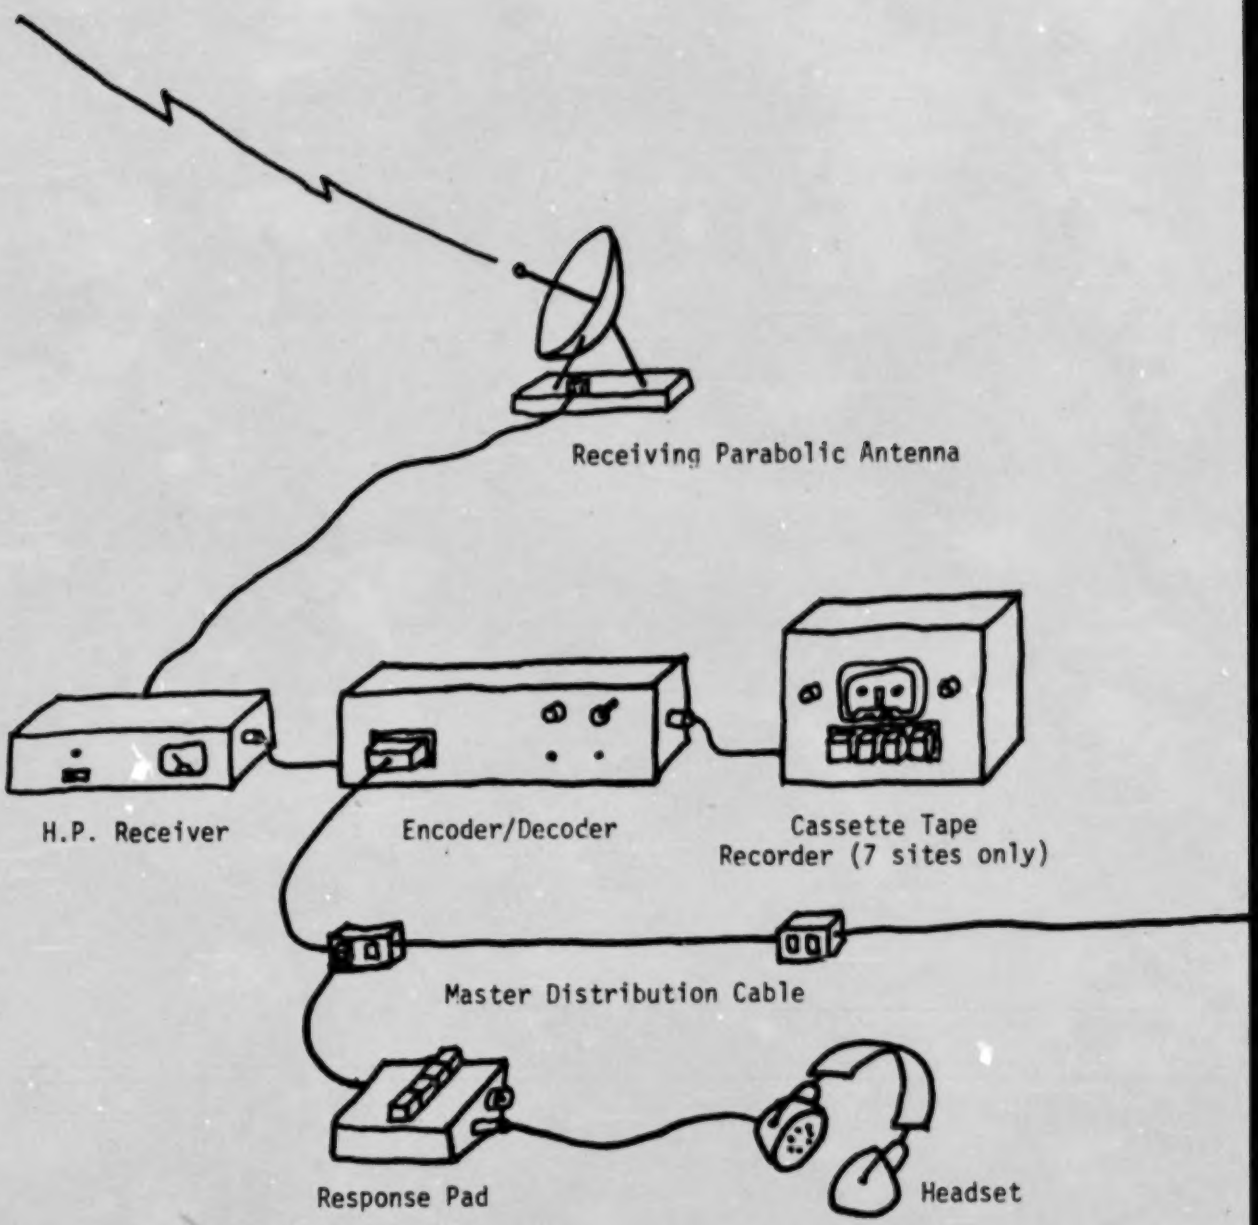
FIG. 10: FOUR-CHANNEL AUDIO REVIEW EQUIPMENT AT CLASSROOM SITES

There was not enough information at the time of this report to make reasonable conclusions about how clear and strong audio reception could be or how well the channel-selection mechanism might work. What can be said is that, due to improperly designed equipment, the voice quality was initially impaired by severe crosstalk from other channels, static, and weak signal strength. AESP Engineering eliminated most of the crosstalk between the channels, caused by the incompatible design

of the H.P. receiver and the classroom disbritution-amplifier, by removing the individual ground on the classroom distribution-amplifier and replacing it with a common ground.

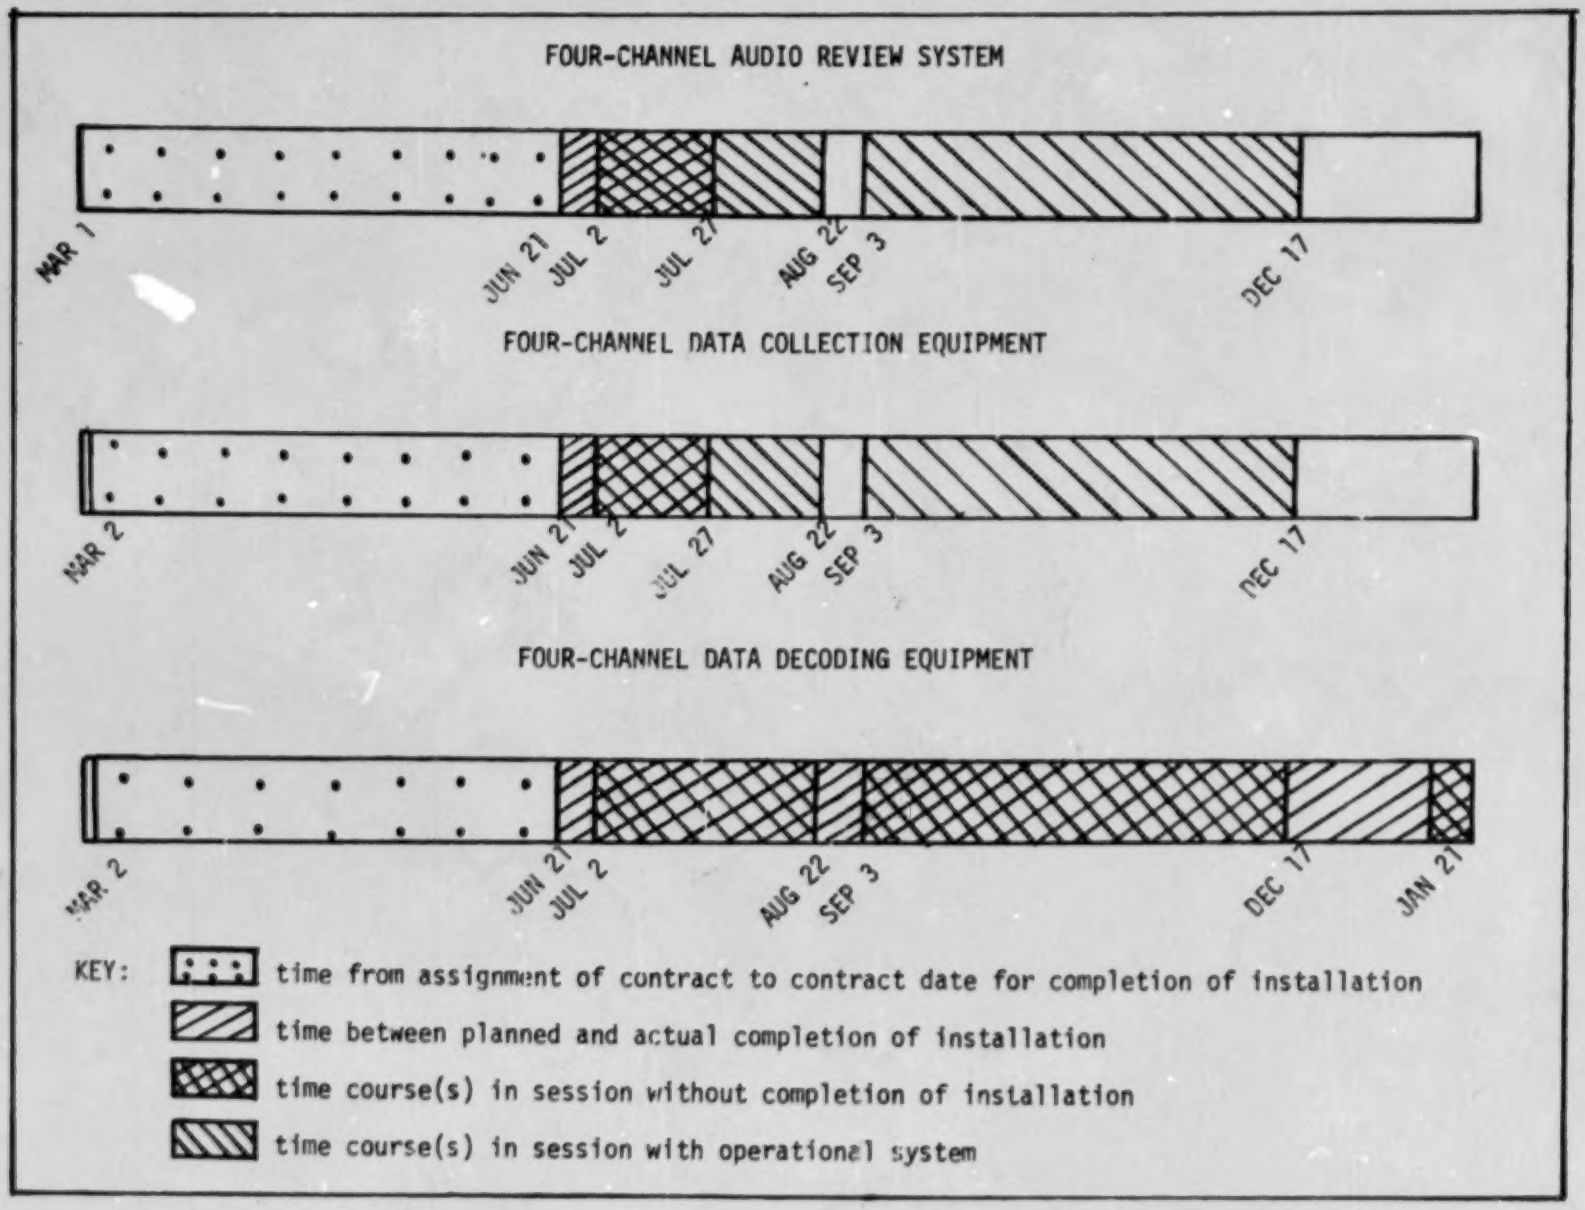
FIG. 11: FOUR-CHANNEL AUDIO SITE RECEPTION EQUIPMENT INSTALLATION SCHEDULE

As indicated in Figure 11, the four-channel audio review equipment was operational at all 15 sites by July 27, 1974. The summer courses were then more than half over. Inadequate quality control by the manufacturer was one of the reasons for the delay. For instance, some of the input sockets from the response pads had to be remanufactured because they were so misshaped that not all the students could plug into the junction connector. There were no audio reviews in the fall course, since it consisted of live, interactive seminars rather than pretaped television programs.

For economic reasons only seven sites were provided with the additional evaluative four-channel audio equipment. As indicated in Figure 11, the four-channel audio evaluation equipment had not been made fully operational as of January, 1975. The classroom encoders for the electronic collection of four-channel audio responses had to be shipped to the sites before they were tested because the master decoder required to translate what was recorded on the encoders had not been constructed. When all the data equipment was installed and tapes were received at the RCC, difficulties were encountered in decoding the tapes. It was discovered that the problem lay in the way the data was recorded.

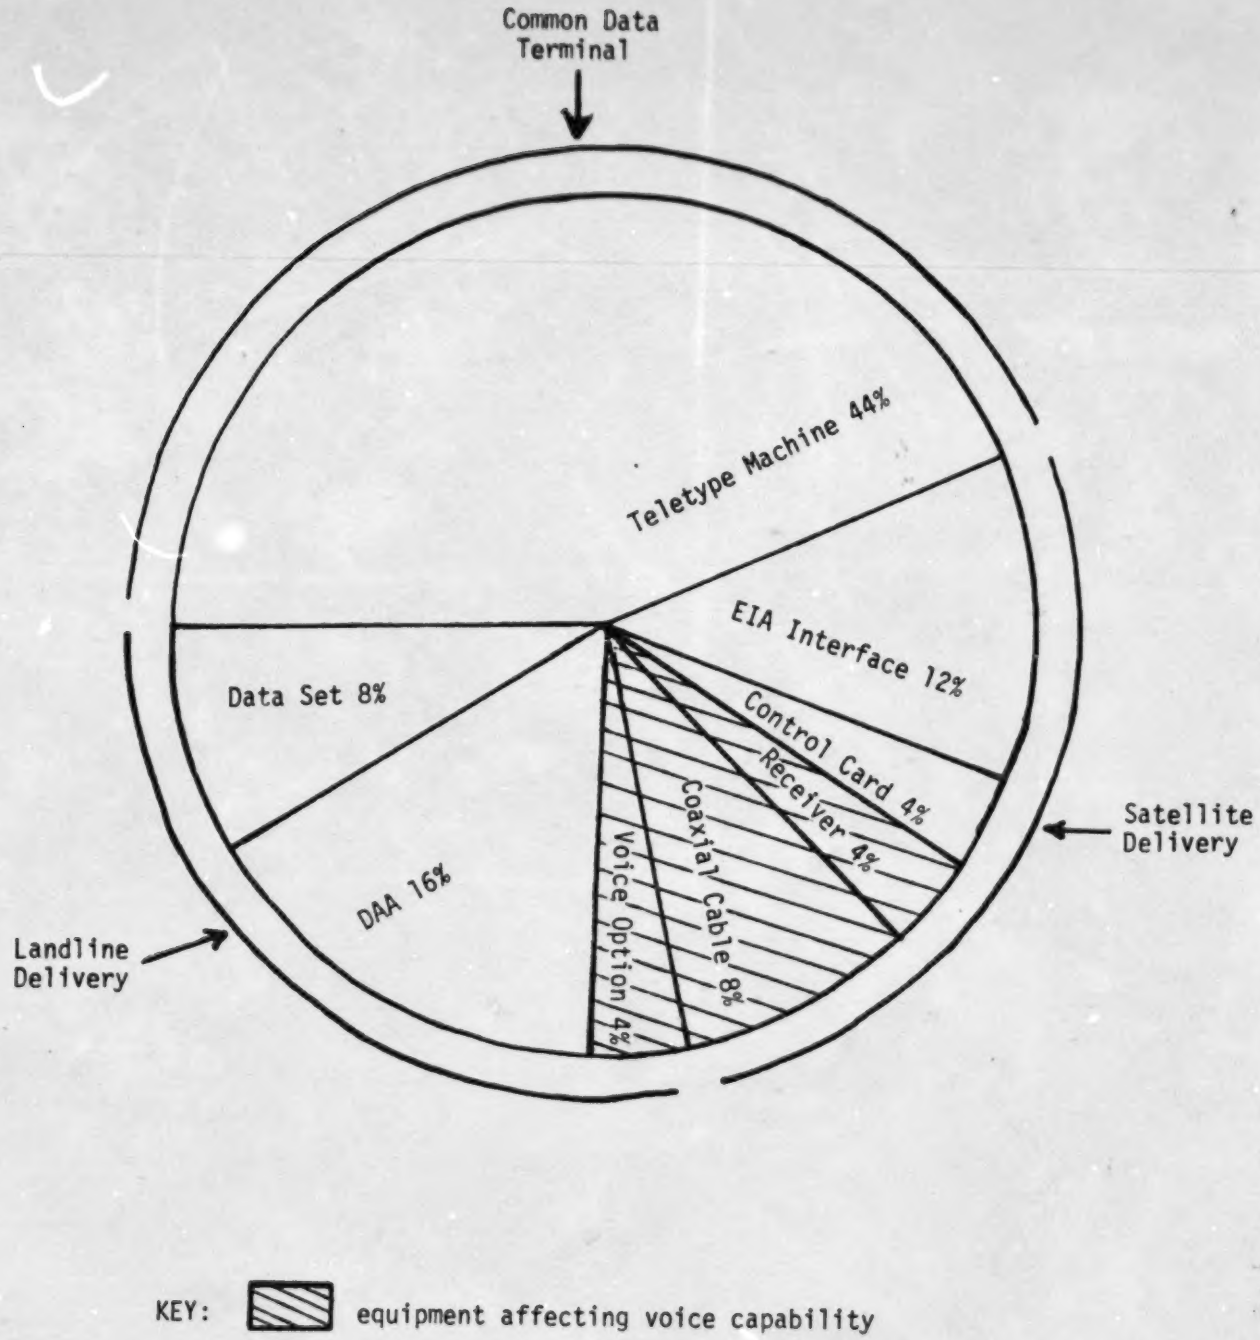
FIG. 15: PROPORTION OF MALFUNCTIONS IN THE VHF-TELETYPE EQUIPMENT AT INTENSIVE SITES

As indicated by the starred dates in Table 4, at the six intensive sites 10 out of the 26 malfunctions disabled both landline and satellite delivery of data. However, all of the 26 malfunctions at the intensive sites rendered only one of the delivery modes inoperative at any one time. Therefore, the main sites were never without either VHF/landline voice or data options. At the ancillary sites there were 16 failures in the landline delivery system that made either data or voice transmission impossible, as indicated in Table 5. While more failures occurred at the main sites that used the communications system more, the main sites were totally without means of communication less often than the ancillary sites.

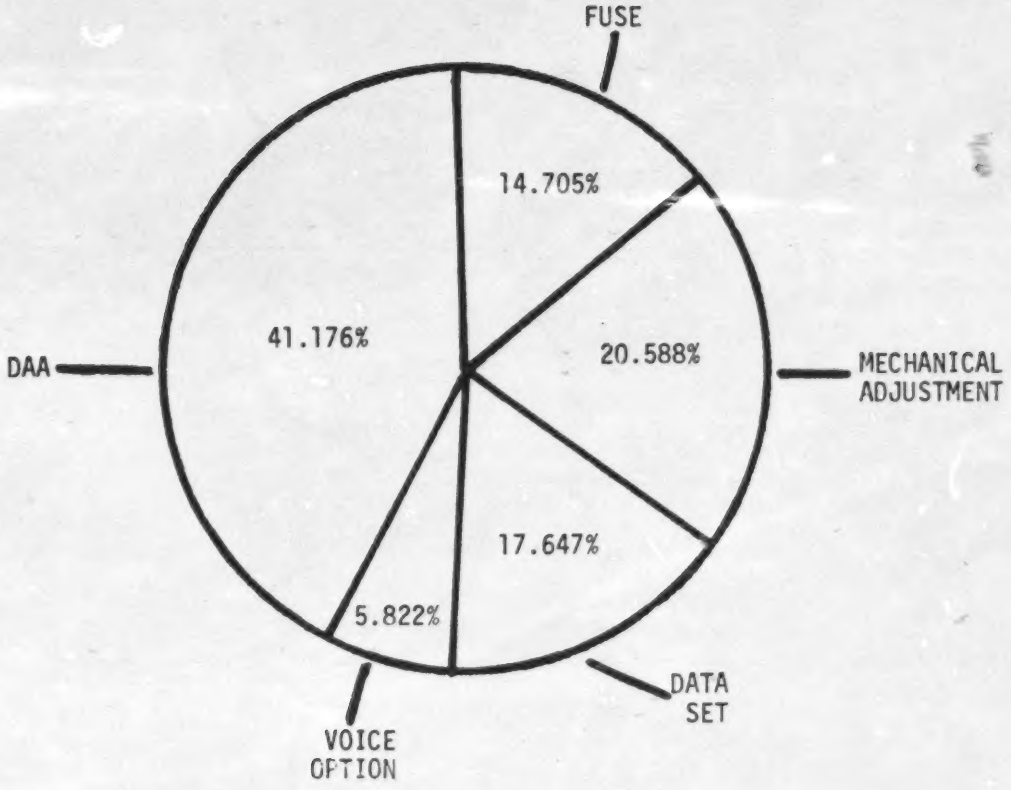
FIG. 16: PROPORTION OF MALFUNCTIONS IN THE TELETYPE SYSTEM AT THE ANCILLARY SITES

The ancillary or receive-only sites were equipped to deliver and receive voice and data via landline. The causes, locations and dates of the 16 malfunctions that occurred at the ancillary sites are identified in Table 5.

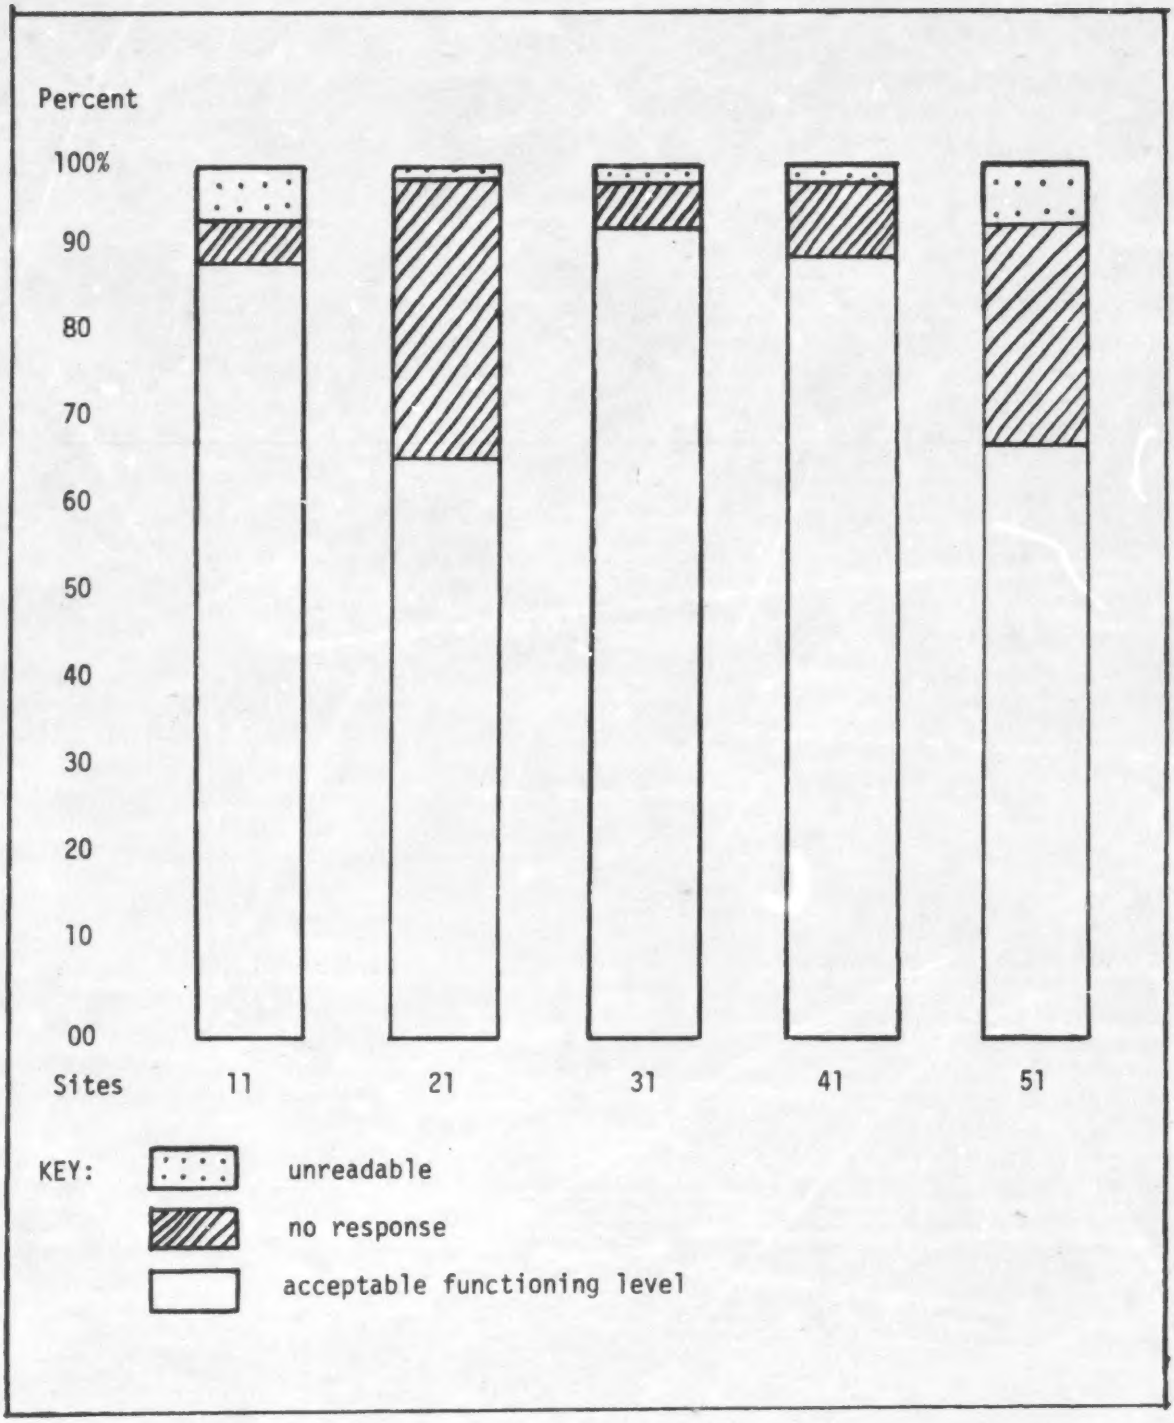
FIG. 17: RELIABILITY OF THE VHF SYSTEM AS A COMMUNICATIONS LINK

If the function of the VHF system is to facilitate communications between the Resource Coordinating Center and the sites, one index to the effectiveness of the system is the number of attempted contacts with the main sites that were successful. The columns in Figure 17 show the proportions of the VHF transmissions for each main site that were readable, not readable, and not answered.
